Manhole Inspection Summary

Manhole # S53K__038MH

Location Address: **rear 3234 fait ave**

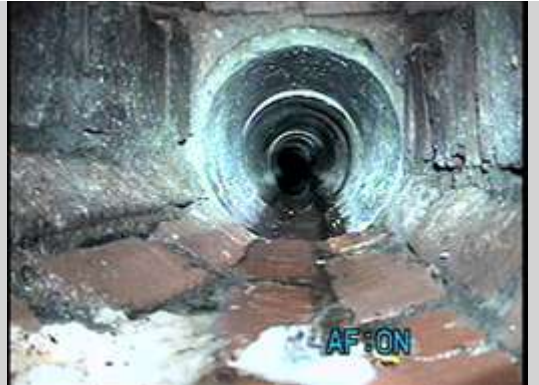
12 O'Clock Outflow

8 in. Circular Gravity Sewer
Pipe Out @ 12 O'Clock

Invert Depth: **10.16** (ft.) Flow Characteristics: **Slow**

Infiltration: **None** Pipe Seal Cond: **Unknown**

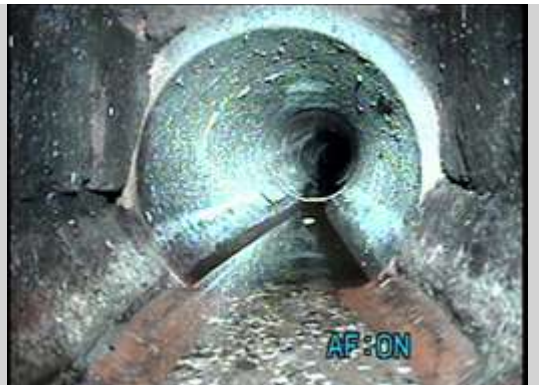
6 O'Clock Inflow

8 in. Circular Gravity Sewer
Pipe In @ 6 O'Clock

Infiltration: **None** Pipe Seal Cond: **Unknown**
